A Replicable and Scalable Near-Zero Net Energy Retrofit of Low-Income Multifamily Housing: Electric Energy Efficiency

ET14SCE1070 & DR14.01.00 Final Report

*Prepared for:
Southern California Edison*

*Prepared by:
Electric Power Research Institute*

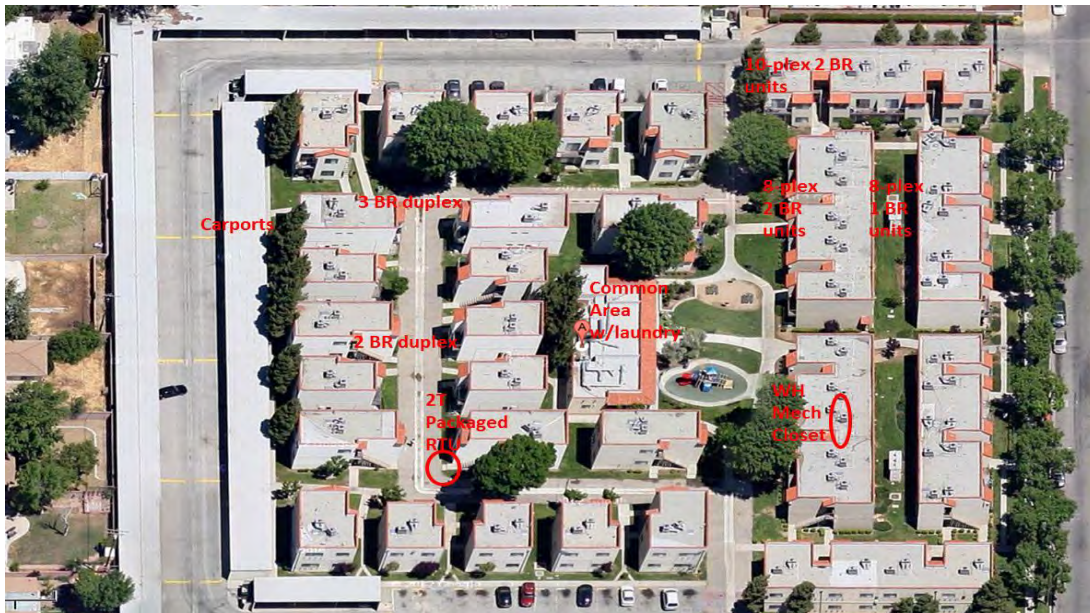
Figure 2: View of Beechwood Property, with Key Energy Systems Identified

Figure 2 is a bird's-eye view of the entire property, with key energy systems, and Figure 3 shows one of the MF buildings at the Beechwood site.

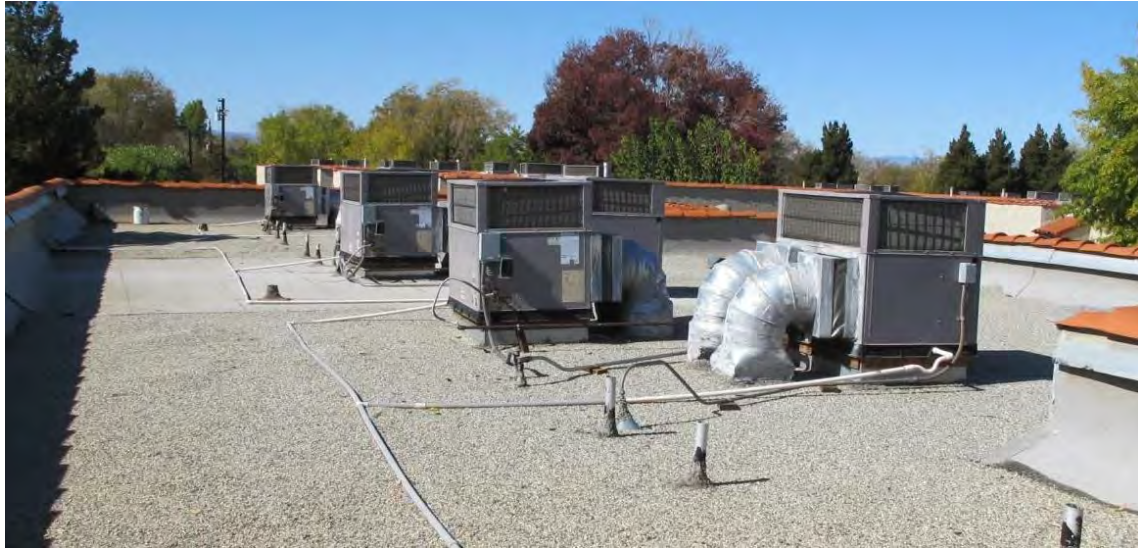
Figure 4: Rooftop Packaged HVAC Units on Building 1

Each of the computer models was developed based on actual buildings, for which energy audits were conducted. Upon an initial visit by the research team, the basic construction type was noted, and the building dimensions measured. The name plates of the rooftop units, furnace, and water heaters for Domestic Hot Water (DHW) were pictured and recorded. The roof-mounted packaged HVAC units on Building 1 were rated at 12 Seasonal EE Ratio (SEER) and 80% annual fuel utilization efficiency (Figure 4). The DHW outbuilding housed two gas-fired, 0.82 energy factor, 100 gallon tanks, which provide hot water to 26 units within Buildings 1 – 3. Figure 5 shows two of three DHW units per outbuilding. Another identical system provided hot water to Buildings 4 – 6. These systems had circulation pumps activated by demand for hot **water, and wouldn't run if the water at the tap was** already hot. Pumps were behind the tanks, and were not visible. The laundry room is well-equipped with 10 washers and 10 dryers, and is located in the back of the common area (Figure 6). The refrigerators were top-freezer style (Figure 7) and the ranges were standard gas fired (Figure 8). All windows were double-pane with metal frames (Figure 9). Figure 10 shows the ceiling insulation through a damaged exterior wall, which exposes an estimated two inches of fiberglass batt insulation.

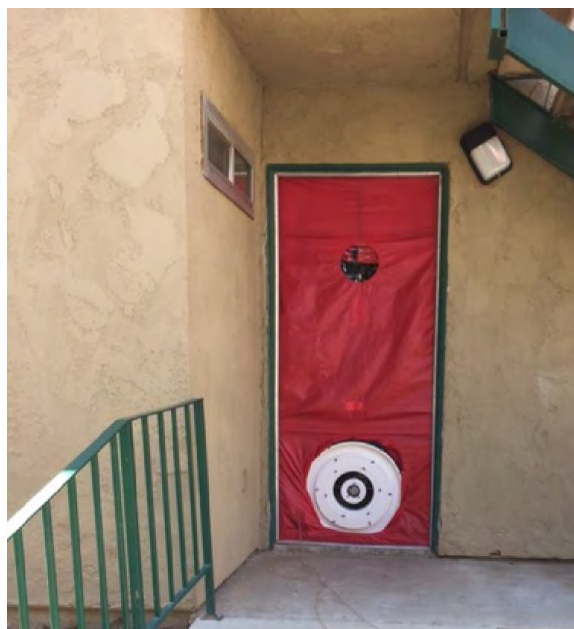
Figure 11: Blower Door Test in Progress

A second site visit was conducted, accompanied by a certified third-party inspection firm. During that visit; blower door, duct blaster, and flow hood HVAC testing was conducted (Figure 11). The envelope leakage (blower door) test and duct blaster test measured **leakage and evaluated the apartment units' thermal performance improvement, and** identified impacts on the energy bills and occupant thermal comfort. The duct blaster test measured duct leakage by pressurizing ducts to 25 Pascals (Pa) and recording the Cubic Feet per Minute (CFM) needed to achieve a stable 25 Pa with the pressure-fan (duct blaster) sealed to **the return, and all supply ducts sealed with tape. Blue painter's masking tape was** used to attach equipment (duct blaster) to the apartment, and to seal any registers, windows, or doors. Envelope leakage (blower door) tests were conducted with all windows and doors closed (except the front door, where the blower door equipment and fan were installed). The apartment was tested at 50 Pa, and the CFM needed to reach 50 Pa was reported. If 50 Pa could not be achieved; the actual pressure was noted on the datasheet. Test results are summarized in Table 5, to assist in developing baseline simulation models.

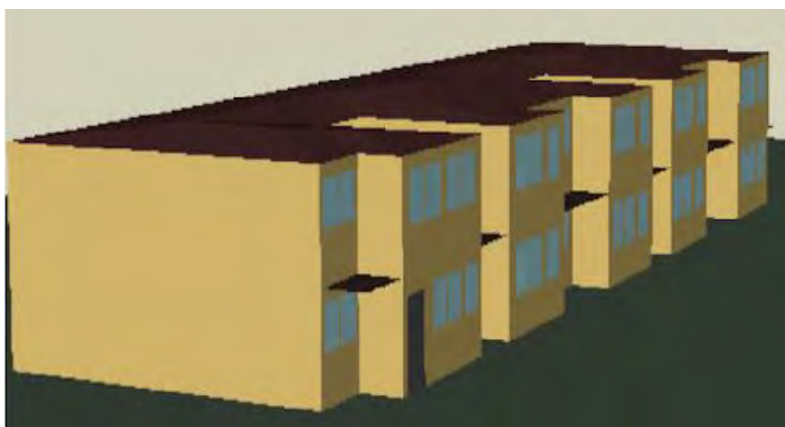
Figure 13 shows the “built-up” model (without adiabatic surfaces). A sample rendering of the various units used in the simulation are shown in the “built-up” input geometry (excluding the adiabatic surfaces).

Figure 13: **3D Image of “Built-Up” EnergyPlus Model Used in Building 2 Simulation**

As mentioned, this “built-up” approach is done because BEopt v2.0.0.6 was then the most advanced version, which couldn’t simulate more than five bedrooms per model. At the end of the project, the team could simulate the entire building using BeOpt v2.6.0.2, and that set of results is discussed in Chapter 6. Thus, Building 21, a duplex of apartments with three bedrooms each, was unique in that each living unit was simulated individually. The input geometry model used for Building 21, with the adiabatic surfaces being either the

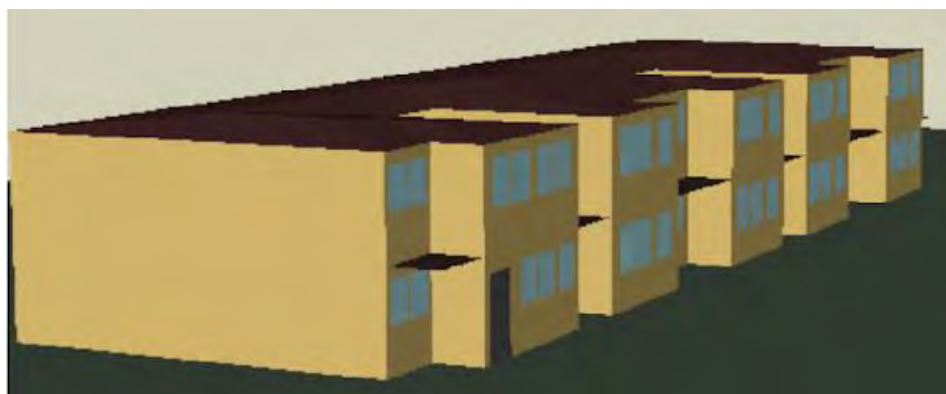
Figure 18: Built-Up Energy-Plus Model of 10-Unit Apartment Building

Energy models of the different building types were generated using a method to build the multiplex buildings from two-unit stacked modules, as described in Chapter 2. The modeling technique involved making computer models of the buildings, using pairs of stacked units (top and bottom units that shared a foundation, roof and walls) using adiabatic surfaces for any walls also shared with neighboring stacked units. All the permutations of end- and middle-units were modeled and simulated. The results from these two-unit models were combined to produce a full, multi-unit building simulation (8-plex or 10-plex; duplexes were modeled directly). A sample rendering of the various units used in the simulation is shown in Figure 18, **in the "built-up" input geometry.**

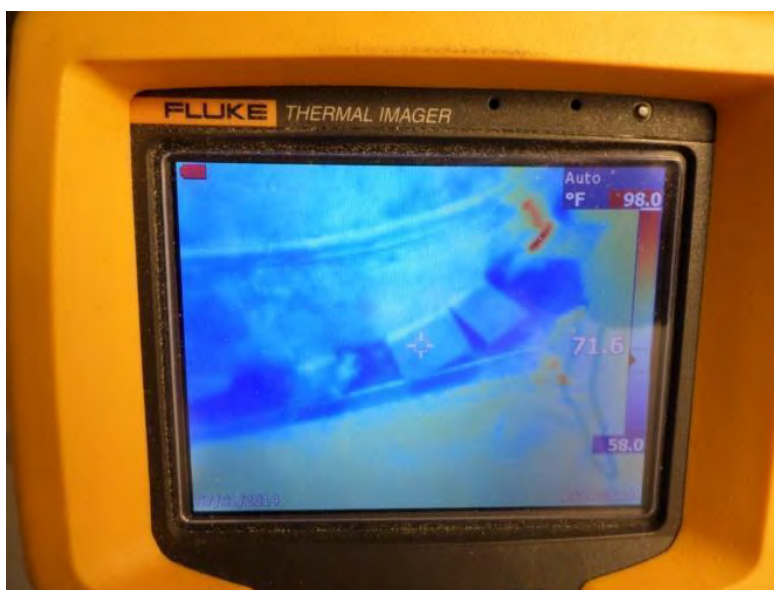
Figure 23: Thermal Camera

During the pilot, when the ceiling was removed to expose the ducts, and prior to their removal and retrofit, their leakage was visualized by smoke test with a thermal camera. Figure 23 shows a thermal view of a duct connecting to the main supply distribution box. The dark blue areas on the thermal camera screen are cold air from the AC unit leaking out into the duct chase. These were typical of the installations in both units. Figure 24 shows a duct collar connected to the duct distribution box. The round duct collar has metal mastic-sealed tabs on each side of the distribution box to hold it securely in place. The tabs are clearly visible, surrounded by cold conditioned air leaking around the connection.

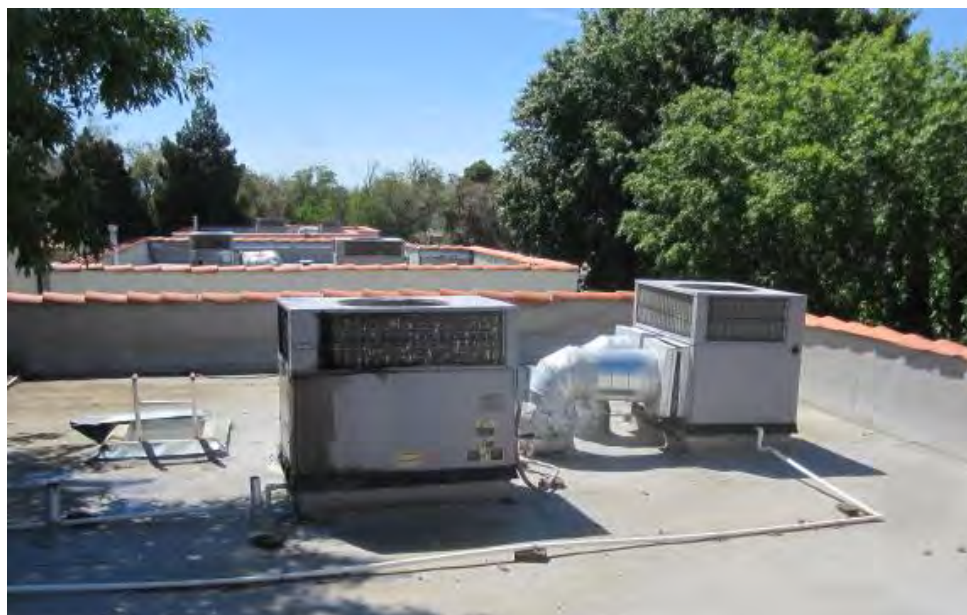
The AC units were labeled with the apartment's unit number, and each duplex had two rooftop AC units, as shown in Figure 29. In addition, the data-collection box was also assigned with a number (in yellow background with red border). Thus, a box ID of "1 B4

Figure 29: Air Conditioning Units on a Duplex Unit

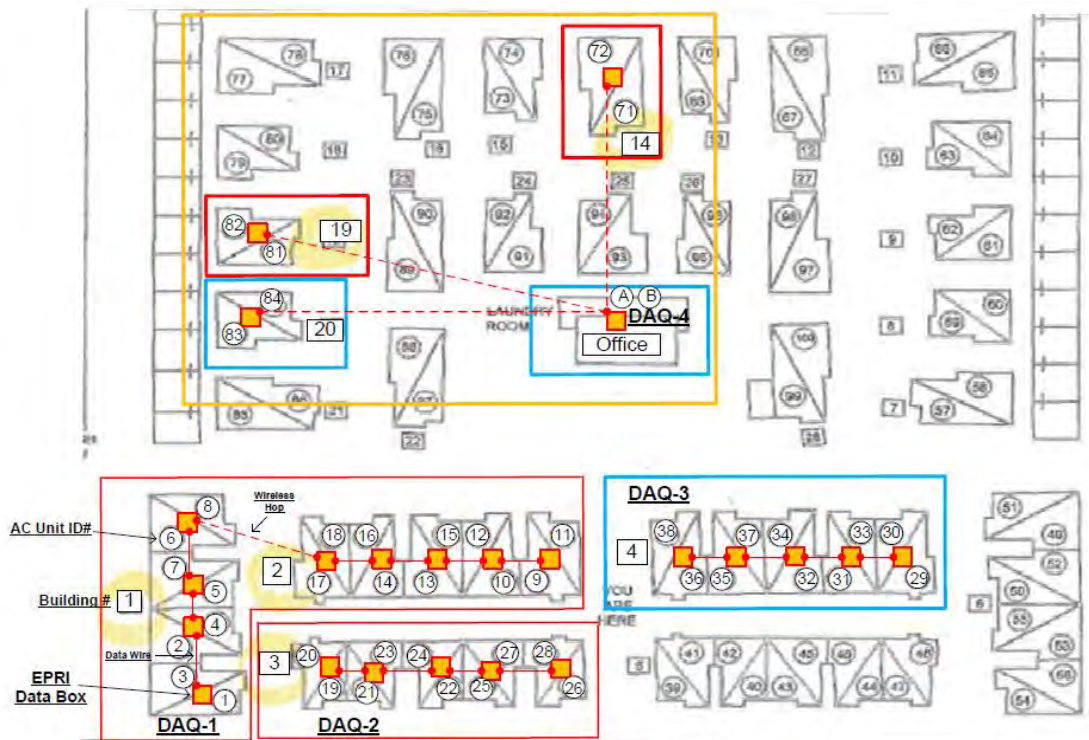
Figure 32: Overview of EPRI Data Acquisition System Layout

As mentioned earlier, the data acquisition boxes covered 30 units and the common area as the treatment group, plus the 10 apartment units as the control group. Figure 32 illustrates the data acquisition systems, which gathered data from the units and transmitted it to the EPRI database. The solid line connections shown in the figure are dry contacts (hard-wired connections), and dashed lines represent wireless data transmission. The RTU’s electrical data (voltage, current, and real power), outdoor air conditions (temperature and RH), duct temperature readings (each apartment unit’s supply air, return air, and exhaust air) and the solar thermal system’s flow rates and temperature readings were recorded in the EPRI database and prepared for download.

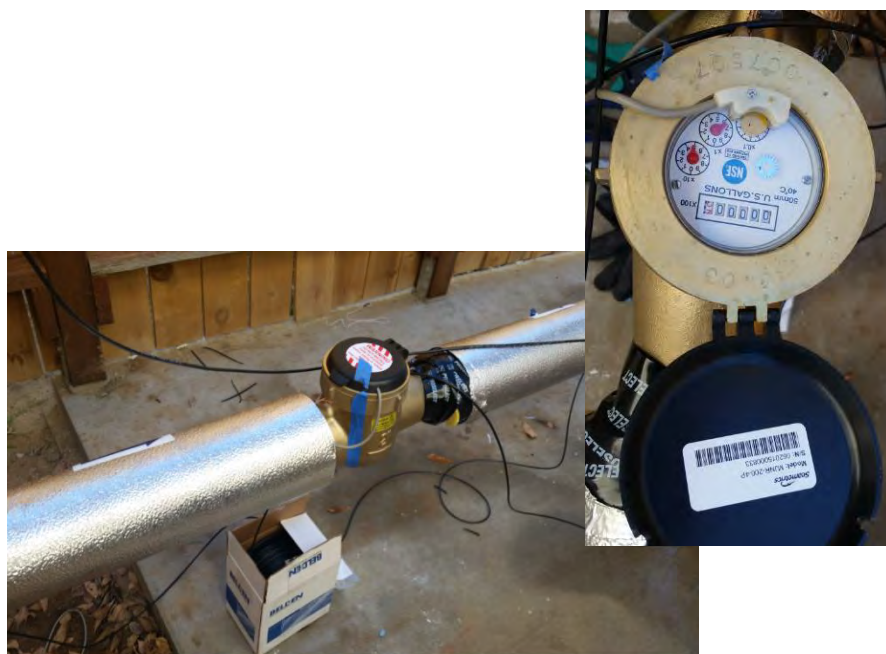
Figure 34: Water Flow Meter Data Collected at Community Water Heating System

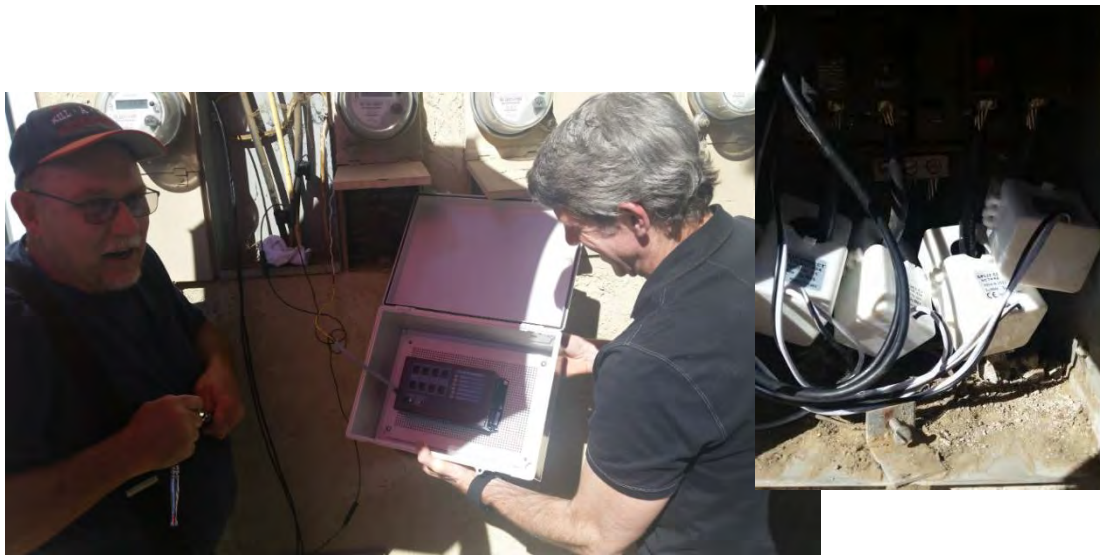
Figure 37 shows the NILM system being installed. The NILM system was installed on Building 1 (an 8-plex) and was monitoring Units #1 - #8, until the hotspot lost its connection. **The NILM system collected data through CTs, to monitor the residences' total energy use, and disaggregate to individual load types.** The metered data was uploaded to **LoadIQ's cloud through a Wi-Fi connection**, in this case using a hotspot located in the case with LoadIQ's EI.X.

Figure 37: Retrofit process of Non-Intrusive Load Monitoring System

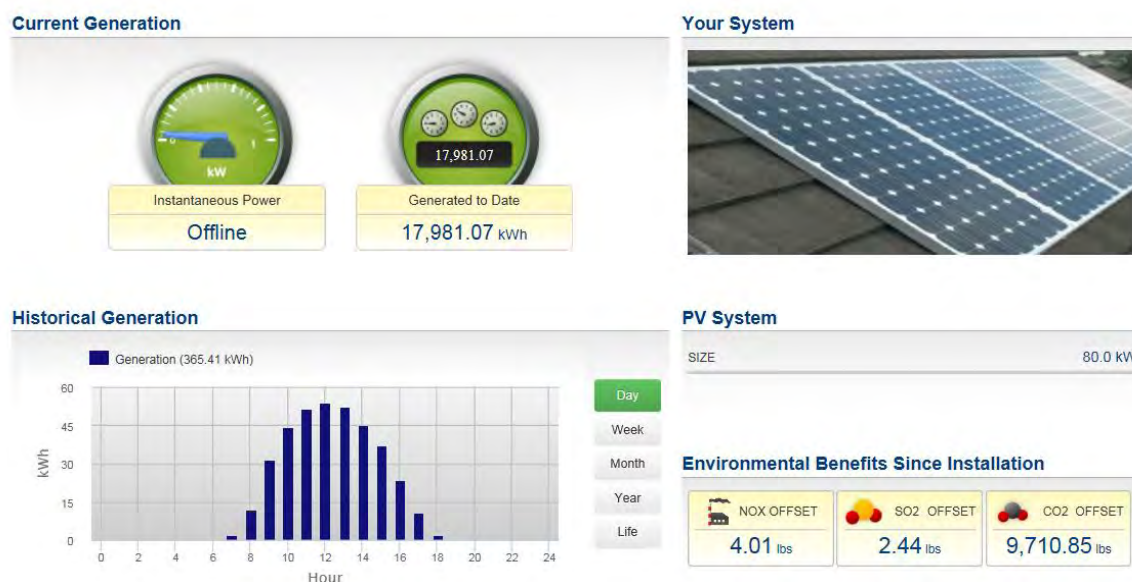
MF rooftops can provide valuable real estate space and add extra value by generating electricity from renewables, such as PV. Beechwood, like many communities, provides rooftop space for mounting PV and solar thermal systems, not only on the apartments, but also on the parking structures. This project retrofitted 30 units. While the PV system was sized to cover the 30 units toward reaching ZNE, the system was connected to provide electricity for the entire community. The research team conducted data analysis for this **community's solar system** as if it were installed for the 30 apartment units to reach near-ZNE. Figure 39 shows snapshots of the PV system and its monitoring interface.

Figure 39: Solar PV System and the Data Monitoring System User Interface

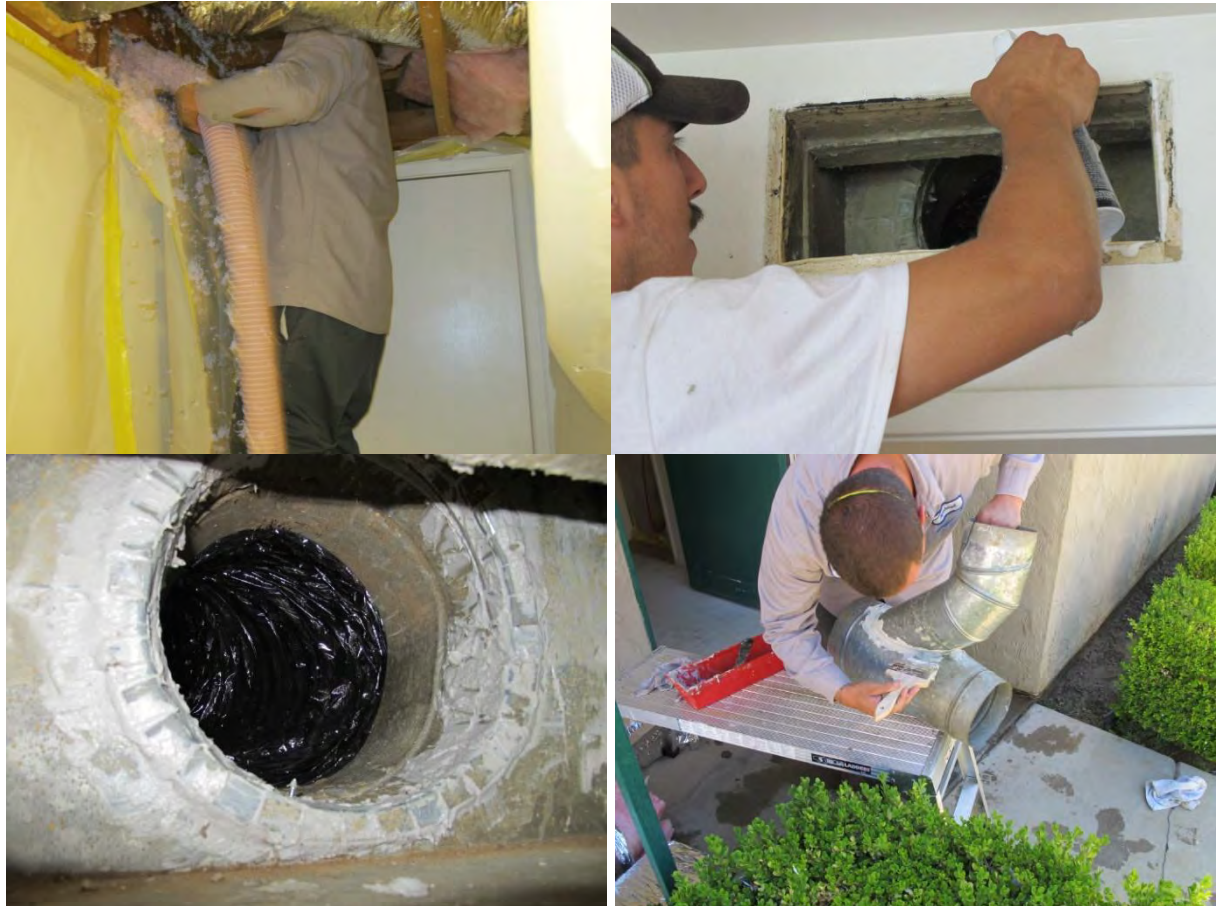
Figure 41: Retrofits to Achieve High-Performance Ducts

Duct sealing was installed to reduce air infiltration and **improve the apartment units'** thermal performance. The entire process consisted of eight steps, listed in the following section as Step A (Test-In) through Step G (Test-Out). Steps A, D, and E were done sequentially, and Steps B and C were completed by the time Step E was completed (Figure 41). Steps A-E were performed on a maximum of two units simultaneously, and if two were performed simultaneously, they were stacked in pairs.

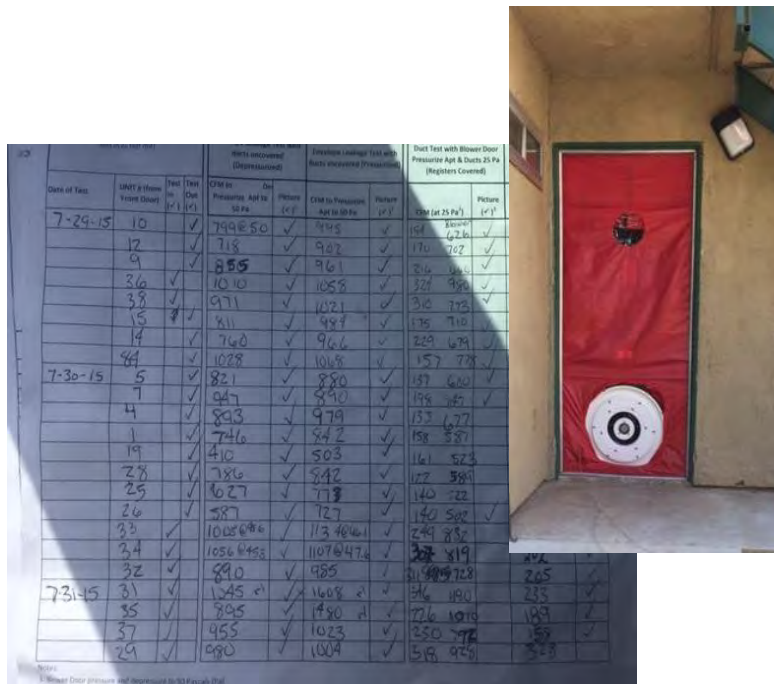
- Perform the blower door test by pressurizing the apartment with the HVAC registers (both supply and return) taped closed.
- Repeat the blower door test by depressurizing the apartment with the HVAC registers (both supply and return) taped closed.
- Repeat the blower door test by pressurizing the apartment, with all the HVAC registers covered.
- Repeat the blower door test by depressurizing the apartment, with all the HVAC registers uncovered.

Figure 42: Blower Door Testing Sheet Data of the Final Commissioning

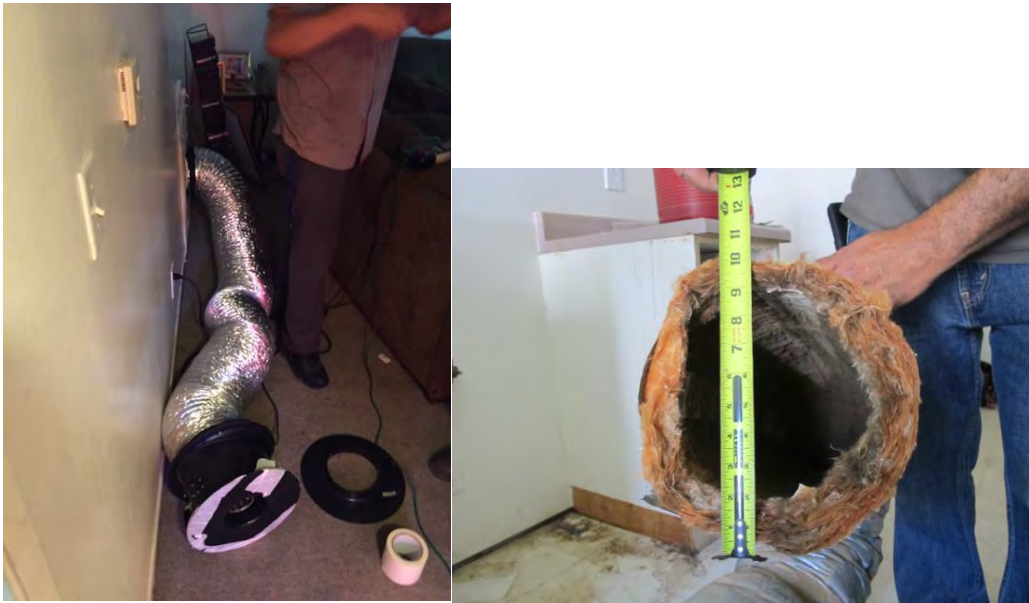
Figure 43: Duct Retrofitting in Progress

4. Verified that the final duct leakage met or exceeded the performance goal of no more than 10% total duct leakage. Some pictures of the retrofitting process are shown in Figure 43.
- Performed a duct-blast test, as described in Section A.1. Duct leakage was not to be more than 80 CFM₂₅.
 - If this goal was not met, diagnostic measures would have been taken to find leaks and seal them, then we would have repeated prior test steps as necessary until the duct leakage target of 80 CFM₂₅ was met.

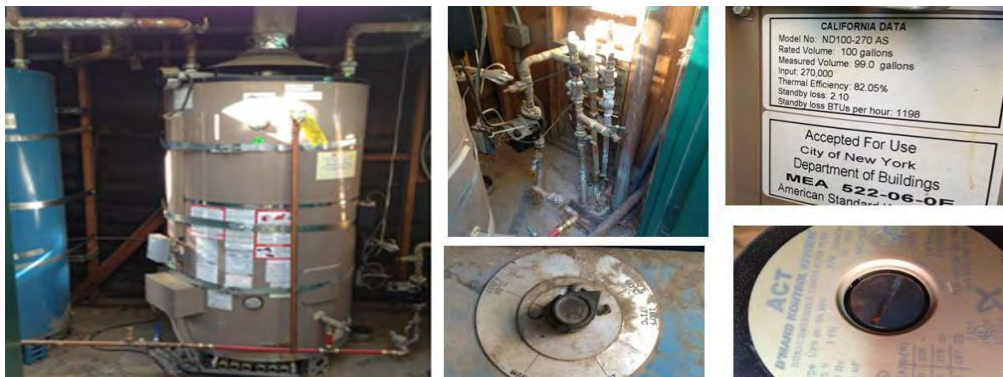
The apartment units' efficient water heating (Figure 44) problem was solved by using SDHW with a gas backup. This solar option was installed by Everyday Energy. The research team reroofed building #3 and placed the solar thermal system on the rooftop. This is a list of the components required to install the system:

- (24) evacuated-tube solar water-heating collectors from Jiangsu Sunrain Solar Energy Co, Ltd., Model: TZ58/1800-30R
- (2) 1,250-gallon water tanks, with heat exchangers
- Crane rental
- Custom pipe covers

Figure 44: Water Heating in Mechanical Closet

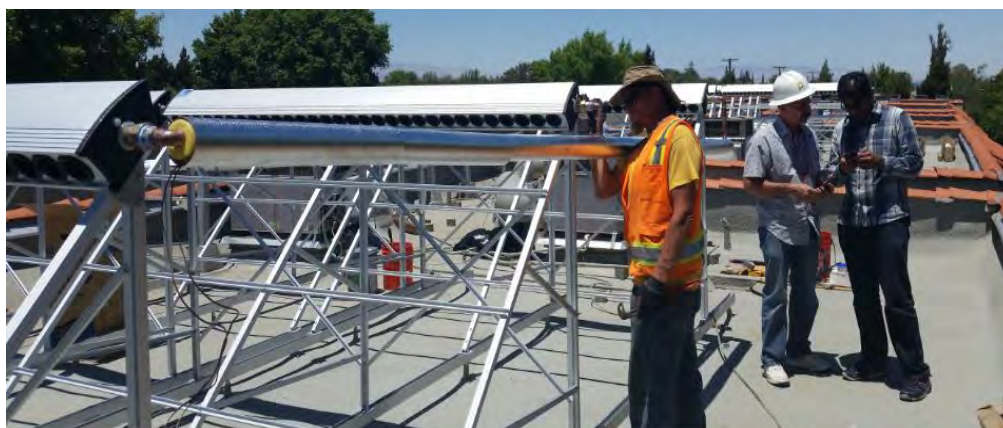
Figure 45: Solar Thermal System Installation and Commissioning

The gas backup was provided by a boiler that had been purchased to replace an old, recently-failed boiler. This system required replacing the existing distribution piping from the central boilers to the buildings. This was achieved by abandoning the existing piping, and installing new, 2"-diameter insulated copper water distribution lines on the roof of one of the buildings (Figure 45).

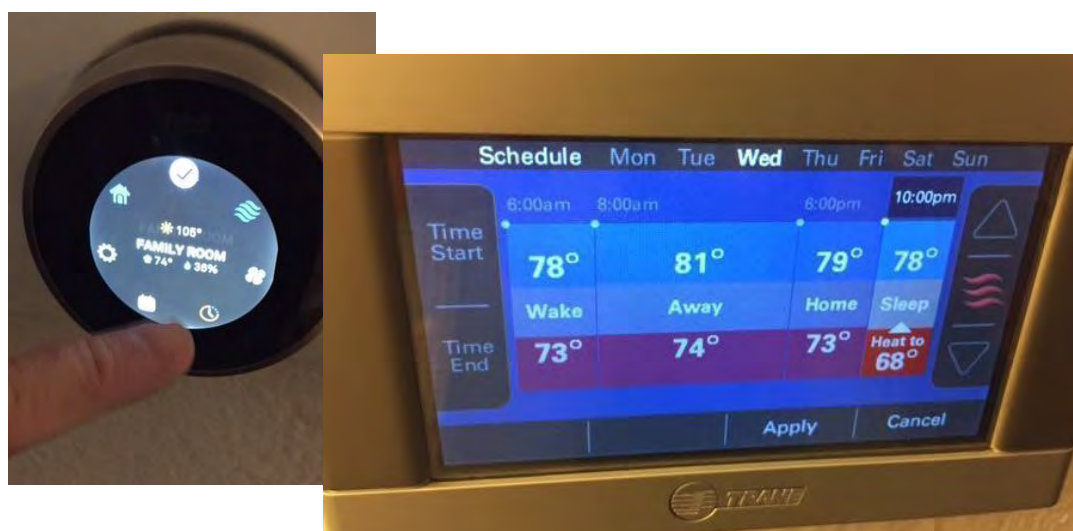
apartment units; their installed photos are shown in Figure 47. **With the occupants'** permission, the HEMS system was configured to collect occupant interaction (such as thermostat temperature adjustment). This information assisted in separating technological and behavioral energy use aspects.

Figure 47: Installation and Commissioning of Home Energy Management System

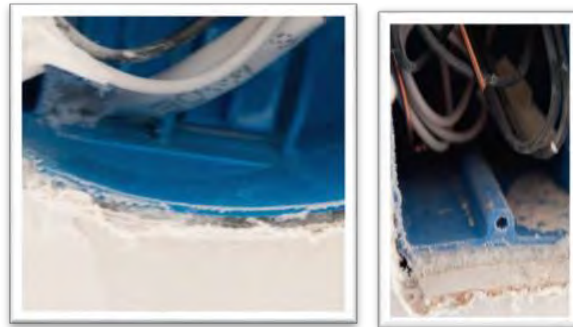
Figure 48: Aerosol Space-Sealing Test for Air Change Rate

The building sealing technology shown in Figure 48 was developed by researchers at UC Davis WCEC. Previous tests have shown a reduction of 50% in leakage areas. The researchers believed it had potential to further reduce the building leakage area. This technology used a compressed nitrogen nozzle to aerosolize the liquid sealant and disperse it, under pressure, into the house. The sealant followed small air streams that formed in and around the leaks; however, the mass of the aerosol caused the particles to hit the edges of the leaks, at which point some of the particles would stick to the edge. Over time, a deposit of the aerosol particles would build up in and around the leaks, sealing them.

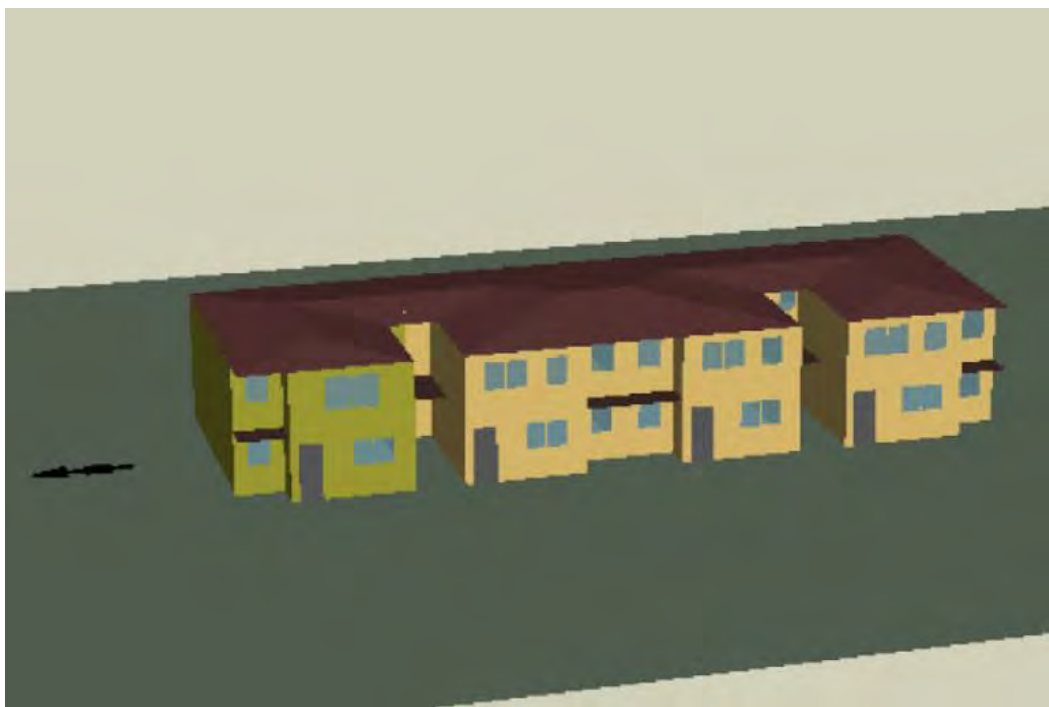
Figure 56: 3D Rendering of Building 1 (Units 1 – 8)

After providing the physical dimensions of Building 1, the team developed the BEopt energy model. The latest version (2.6) was the first to allow input from low-rise buildings with fewer than four stories. This version, as shown in Figure 56, also provided a building rendering, which was useful in checking the simulation input data. Using the simulation results from the hourly models, the team investigated the impact of various EE measures on the improved baseline features.

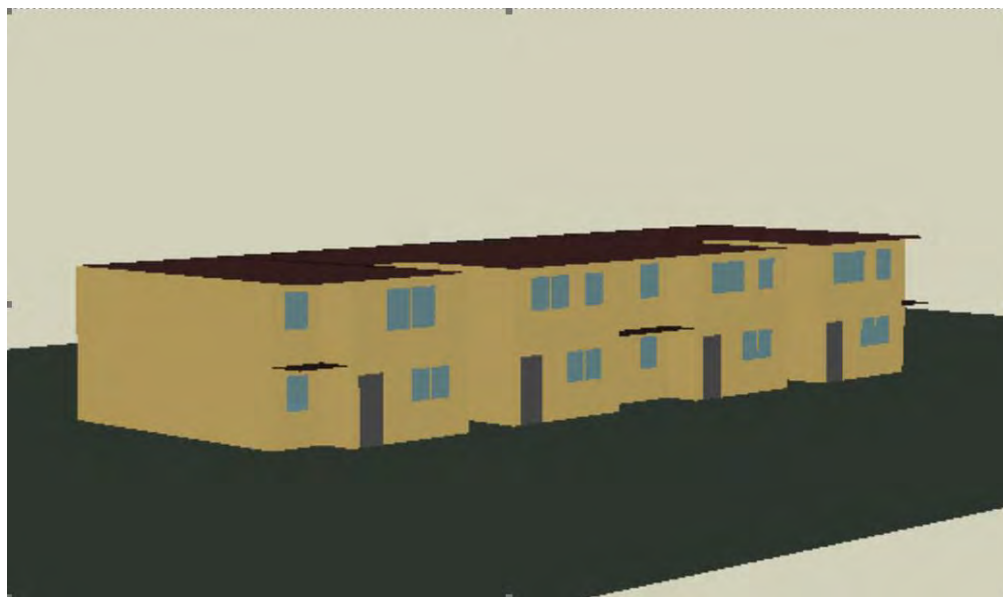
As with Building 1, the Building 2 model was simulated using BEopt v2.6. A graphical representation is shown in Figure 60. Using simulation results from the hourly models, the team investigated the impact of various EE measures on the improved baseline features.

Figure 60: 3D Rendering of Building 2 (Units 9 – 18)

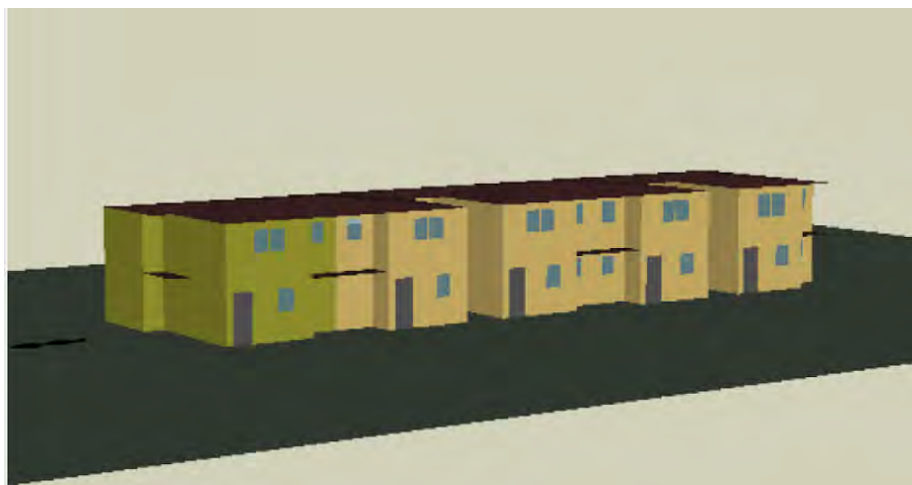
Building 3 was modeled using the analysis outlined for the previous two models. A graphical representation of Building 3, generated using BEopt, is shown in Figure 64.

Figure 64: 3D Rendering of Building 3 (Units 19 – 28)

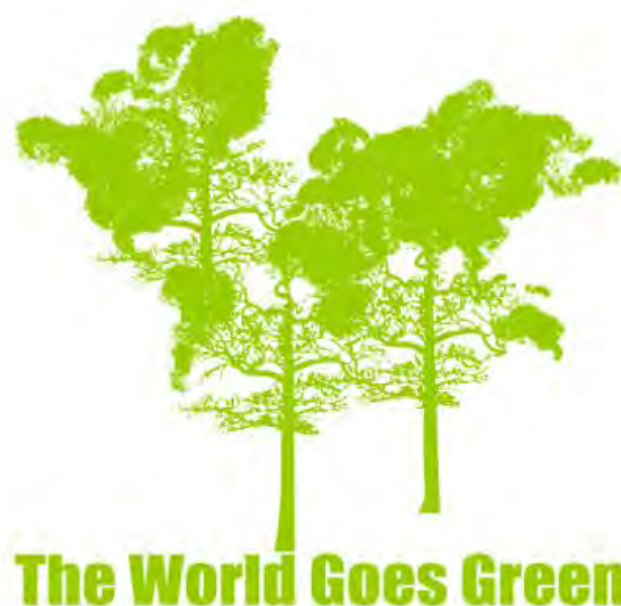
Figure 112: Impact of California Codes

The presenter spoke about the California ZNE goal for all new residential buildings to be ZNE by 2020, and for all new commercial buildings to be ZNE by 2030. The codes and standards require buildings to be more energy efficient, and specifically to be ZNE, in California (Figure 112 - Figure 113).

2013 CA energy codes
raised efficiency
standards by
25%
moving towards
Zero Net Energy by
2020

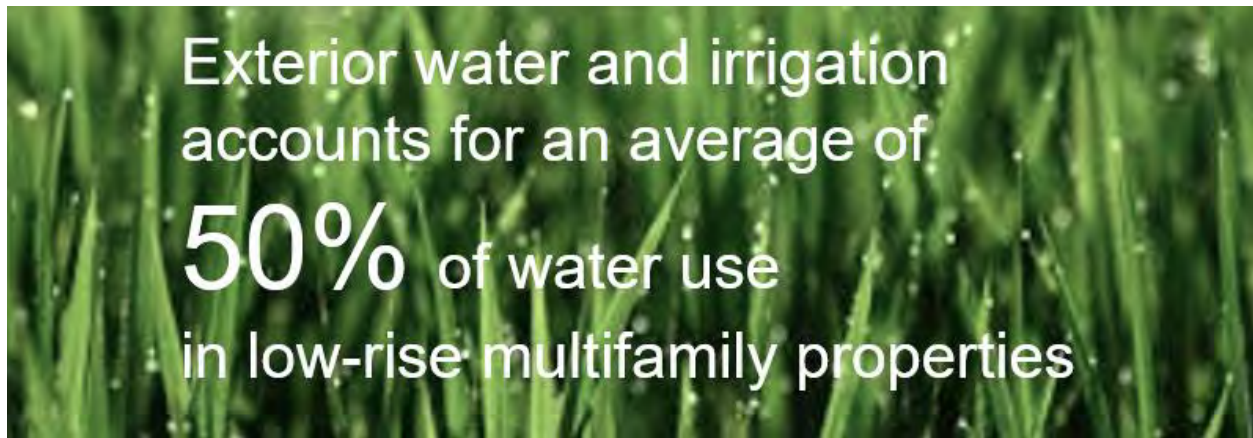
Figure 115: Impact of Water Use

Irrigation water accounts for 50% of water use in low-rise MF properties. The presenter mentioned that it is also nearly half of the utility cost paid by the owner. So, irrigation water can be a big potential for savings (Figure 115).

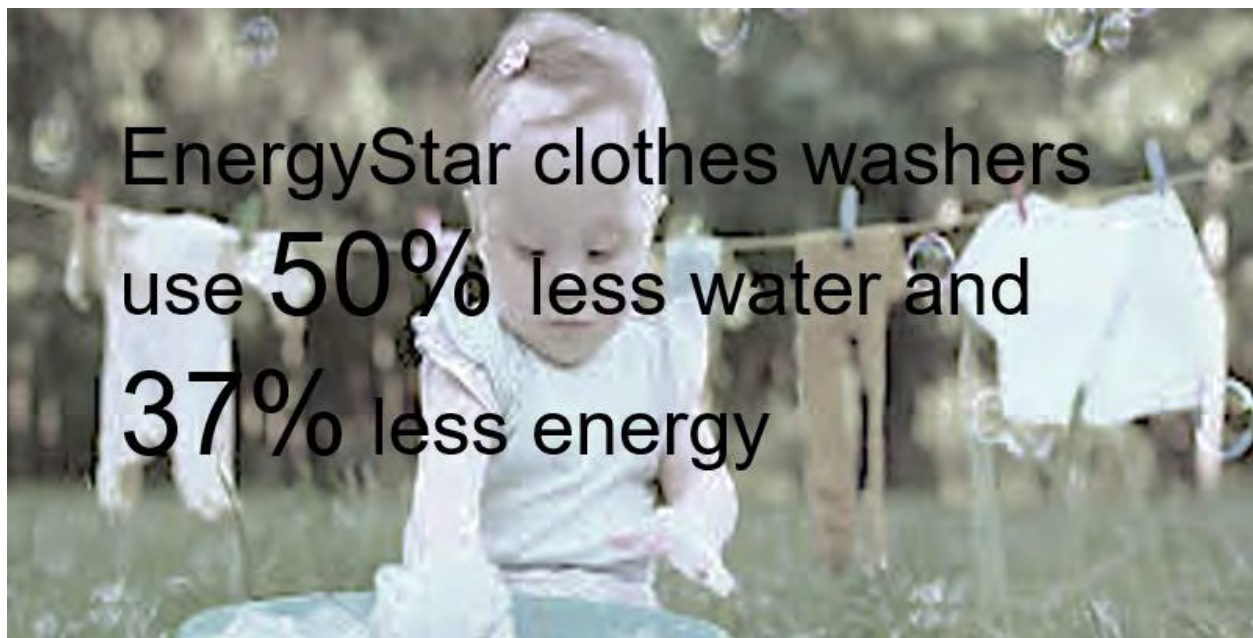
Figure 116: Water Use in Washing Machines

One area commonly overlooked for water reduction is washing machines (Figure 116).

The presenter mentioned that if the community has centralized laundry rooms, even if the supply and maintenance of the machines is outsourced, the utility costs are typically paid **under the property's operating costs**. **Requiring vendors to supply energy-efficient** equipment helps keep the costs down, both for the water and the energy to heat the water.

The presenter said that one way to take this a step further is to consider encouraging cold water washing to reduce energy use. A study conducted by the Alliance to Save Energy showed that in locations where there were price variations for cold, warm, and hot water washing, with the cheapest price offered for the cold water wash, energy use could be reduced by as much as 30%.

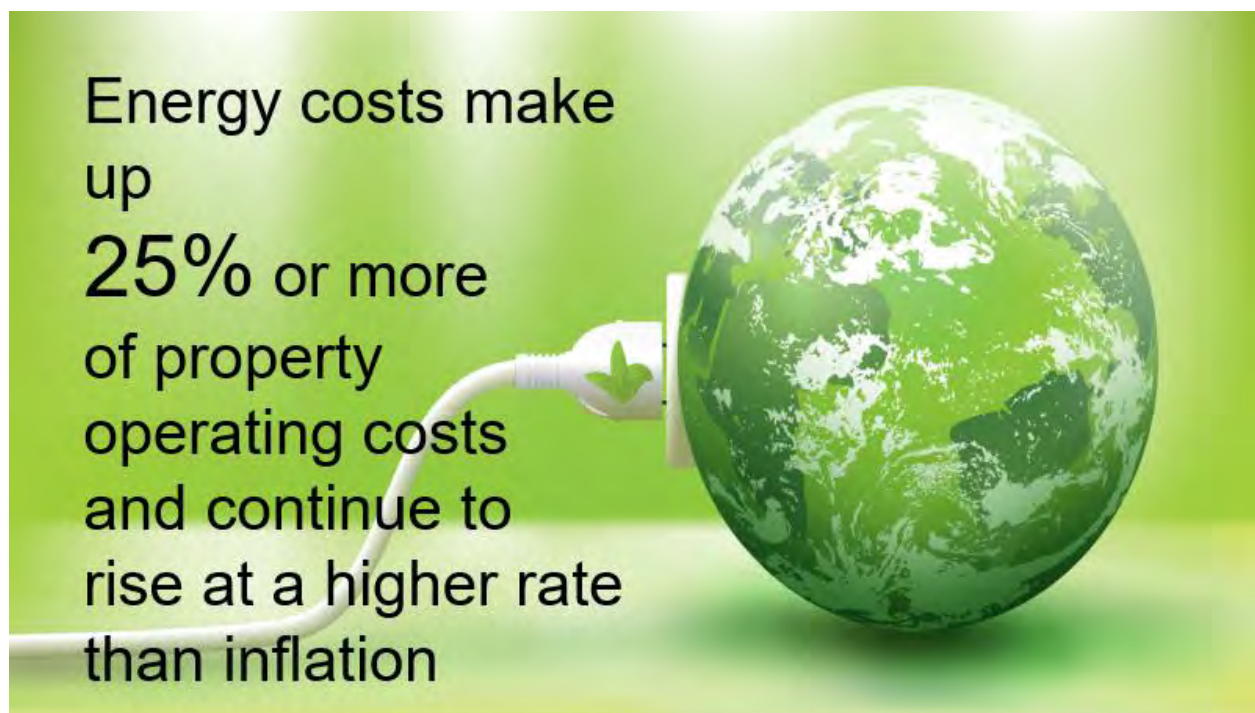
Figure 117: Energy Costs

Commercial electricity rates increased an average of more than 7% just from 2013 to 2014. Natural gas pricing has increased at about 5% per year, and these trends are expected to continue with no drop off in sight (Figure 117).

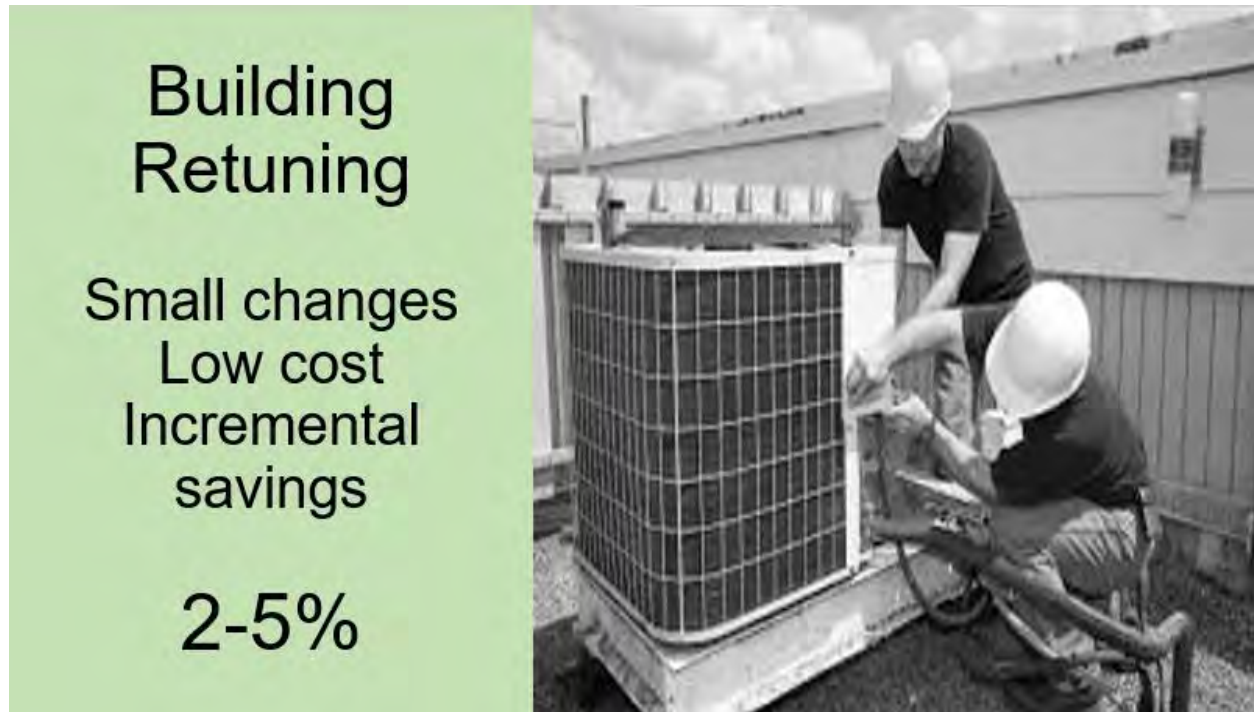
Figure 119: Building Retuning

Another opportunity to take advantage of is retro-commissioning, also referred to as “building re-tuning” (Figure 119). **It’s been reported that up to 20% of the energy used in commercial buildings is wasted because of improper operations.** Building re-tuning provides a way to have an immediate impact, especially in the often-overlooked small building market, which includes many MF buildings. Small buildings are usually those under 100,000 square feet, which frequently don’t have centralized building automation systems. These

buildings often have package units for heating and cooling, and are controlled by zone thermostats.

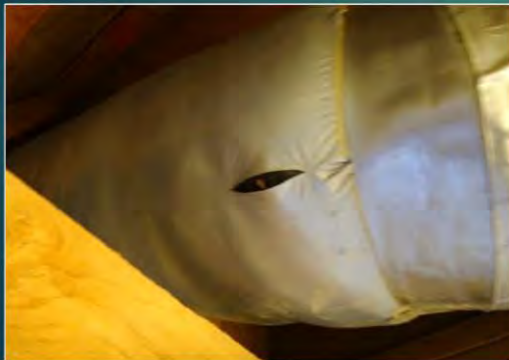
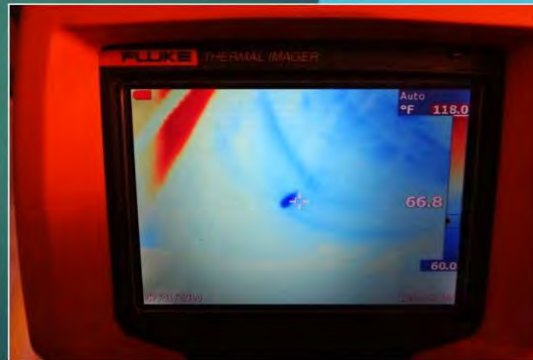
Figure 124: **Advanced Building Diagnostics Posted on SCE's Site**

This ZNE Retrofit showcases a range of high-efficiency Demand Side Management (DSM) technologies on 30 units in a 100 unit apartment complex of 1970's low-income multi-family (LIMF) type housing.

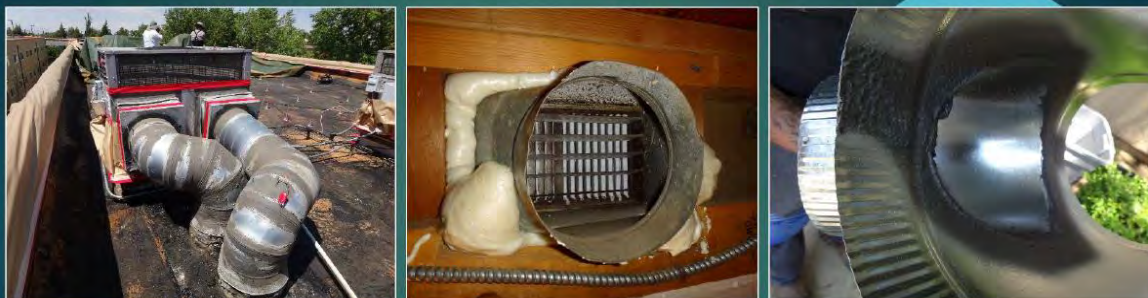
Figure 125: Ductwork **Sealing and Replacement Posted on SCE's Site**

Ductwork Sealing / Replacement
