Mosaic Gardens New Construction, Low-Income Multifamily ZNE

DR15.21 Final Report

Kliewer and Associates, LLC for

March 4, 2020

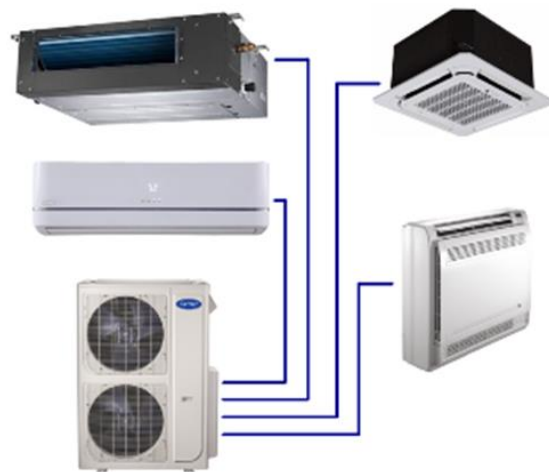
Figure 1: Heat Pump System

Figure 1 at right illustrates a typical configuration installed at the site. The condensing unit is shown on the lower left, which is installed on the roof. The ducted fan coil unit (FCU) is shown on the upper left of the diagram.

These are installed in a central location in the hallways in a soffit above the ceiling in each apartment, with ducts that extend to the rooms of each apartment.

Some rooms are conditioned without the need for a duct because of the location of the ceiling unit. The FCU's are accessible through a return grille/hatch located in the hallway of each apartment, directly below the FCU.

The heat pump condensing units are located on the roof of the building and fan coils are located above the ceilings in each apartment and the Community Center. The fan coils and condensing units are connected by refrigerant piping and low voltage control wiring.

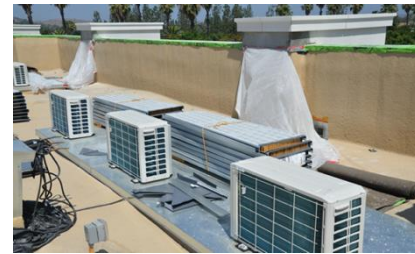
Figure 2: Ducted Mini-Split Heat

The installed rooftop HVAC condensing units are shown in Figure 2. This installation includes a raised curb with sheet metal caps supporting the condensing units.

Refrigerant lines and electrical service and control cabling is extended through the roof through a sealed sheet metal roof jack.

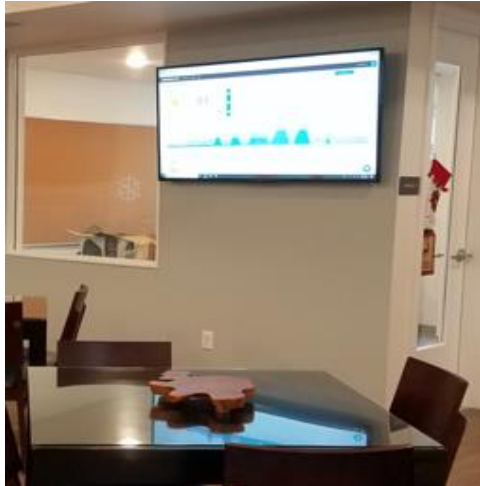
Figure 5: Dashboard Display in Community Center

Dashboards for the thermostats allow a quick overview of individual apartments and all the units in the multi-family building complex.

The dashboard is prominently displayed in the Community Center, shown in Figure 5, to keep tenants interested in the subject of energy use and mindful of actions they can take to keep their electric bills low.

Building management can utilize the dashboard to keep track of the status of each unit in the building. It indicates whether each unit is running heat or air conditioning, and whether there is any malfunction.

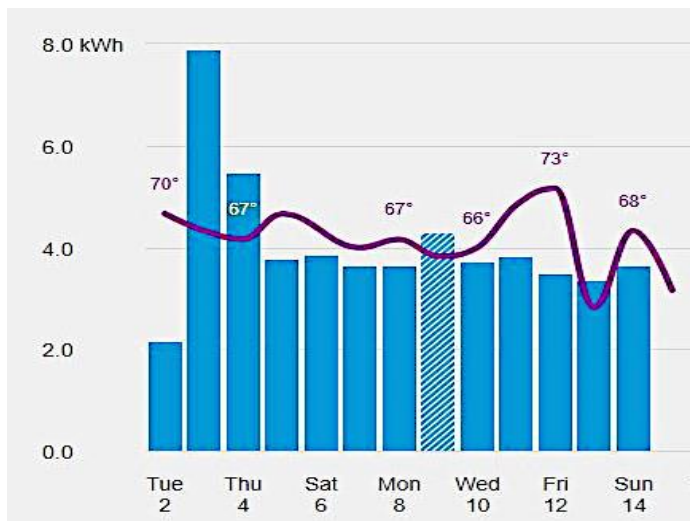
Figure 6: Temperature versus Energy

Figure 6 shows temperature and energy use over a six-day period. The dashboard also allows users to view this information on an hourly basis.

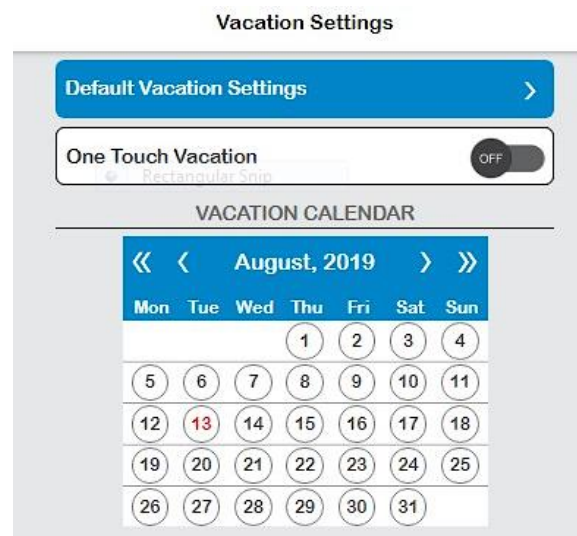
Figure 7: Vacation Mode on Thermostat

Individual dashboards for building tenants have advanced features and allow customization to reduce energy use. The dashboard has a menu that can be personalized by individual tenants. They can select setting such as vacation mode, shown in Figure 7 below.

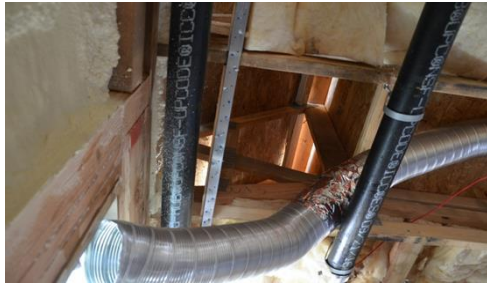
Figure 8: Insulation Challenges

in the form of infiltration and exfiltration depending on the stack effect cycle. Closed cell spray foam insulation was selected as the best option to insure an airtight, insulated envelope.

The building's architectural features were challenging to insulate and seal properly. These features, while visually attractive, are vulnerable to energy from thermal shorts and excessive air leakage in the

A particular challenge at this site was the building's architectural features that were difficult to insulate and seal properly. These construction details added multiple layers of subcontractor effort that had to be carefully coordinated by the site Superintendent. They pose a potentially high risk as energy loss areas from thermal shorts and excessive air leakage in the form of infiltration and exfiltration depending on the stack effect cycle.

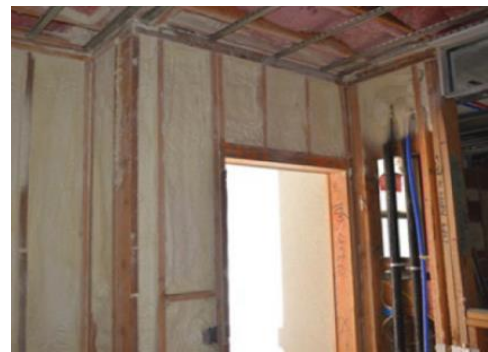
Figure 9: CCSF Foam Insulation

This was used on the exterior building walls, the partition walls between apartments and the top floor attic. Figure 9 shows CCSF installed between units, with a staggered-studded framed wall.

Closed cell spray foam insulation is a high-performance building envelope measure that was used on the exterior building walls, partition walls between apartments and the top floor attic. CCSF insulation was selected for this project because of its excellent thermal properties, its structural shear value and clear superiority to fiberglass batts, blow-in fiberglass, open cell spray foam and others forms of insulation still in common use.

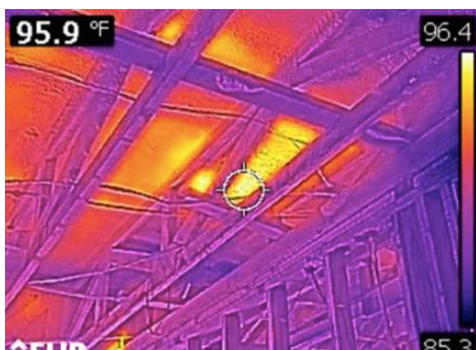
Figure 10: Thermal Imaging

The finish does not provide insulation on its own, but the use of CCSF helped the total assembly tightened the building. Figure 10 shows thermal imaging used to identify deficiencies before construction was completed.

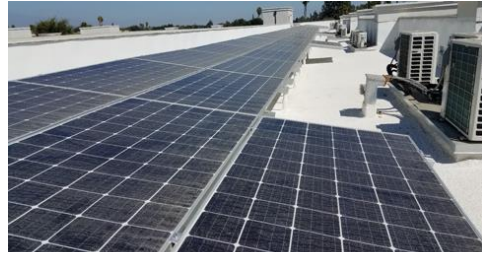
Figure 11: Solar PV Array

The building required a source of renewable energy to attain ZNE status. Rooftop solar PV was installed as the source that would serve the building. A 34-kW rooftop PV array brings the Community Center of the building up to ZNE. Additional solar PV would be needed to be needed for the entire building to qualify as ZNE.

The renewable generation on this project is a 34-kW rooftop PV array to serve the Community Center. This array was not sized large enough to allow the 46 apartments in the building to reach ZNE. It would have required a PV array nearly double in size to fully meet ZNE for the entire project. For now, the Community Center has achieved ZNE status and the remainder of the building is ZNE ready.

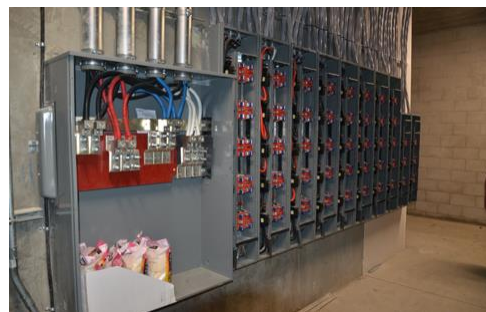
Figure 12: Meter Base for the 46 Apartments

SCE managed the installation of the EPRI-supplied plug-load monitoring equipment on all circuits throughout the entire complex. Each individual electrical circuit is monitored in each apartment and in the common areas. Lights and outlets within the apartment units were wired so they could be monitored separately.

Figure 13 shows the meter base for the 46 apartments. This data will be analyzed by EPRI used to develop customer and measure profiles and identify opportunities for demand response.

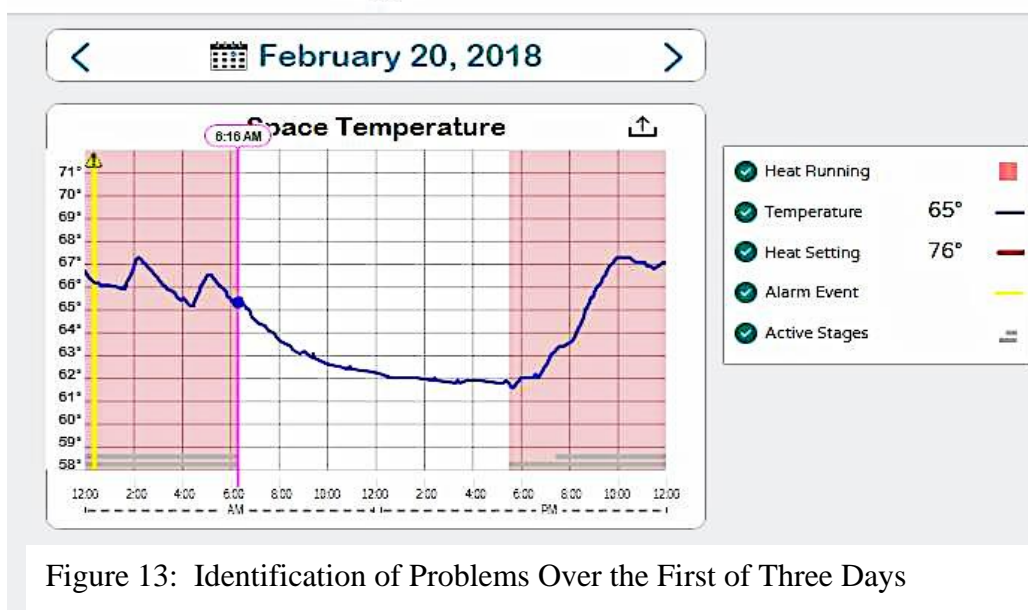
Figure 13: Identification of Problems Over the First of Three Days

A situation during the winter of 2018 provides an example. A unit with low refrigerant charge was unable to achieve its 76° setpoint. Over the course of three days information was sent via text to the HVAC technician prior to a site visit. Figure 13 illustrates the situation on day 1. The team was able to observe this problem remotely and call for service. The technician picked up the needed refrigerant on the way over, saving time for both the contractor and tenant. The building management was delighted with having a tool they could review this kind of information. Many service calls can and are being solved in this manner.
